**Aquatic Plant Management Plan 2007-2011
Big Turkey Lake
Lagrange, Steuben County, Indiana**

Prepared for the Big Turkey Lake Association

February 25, 2008

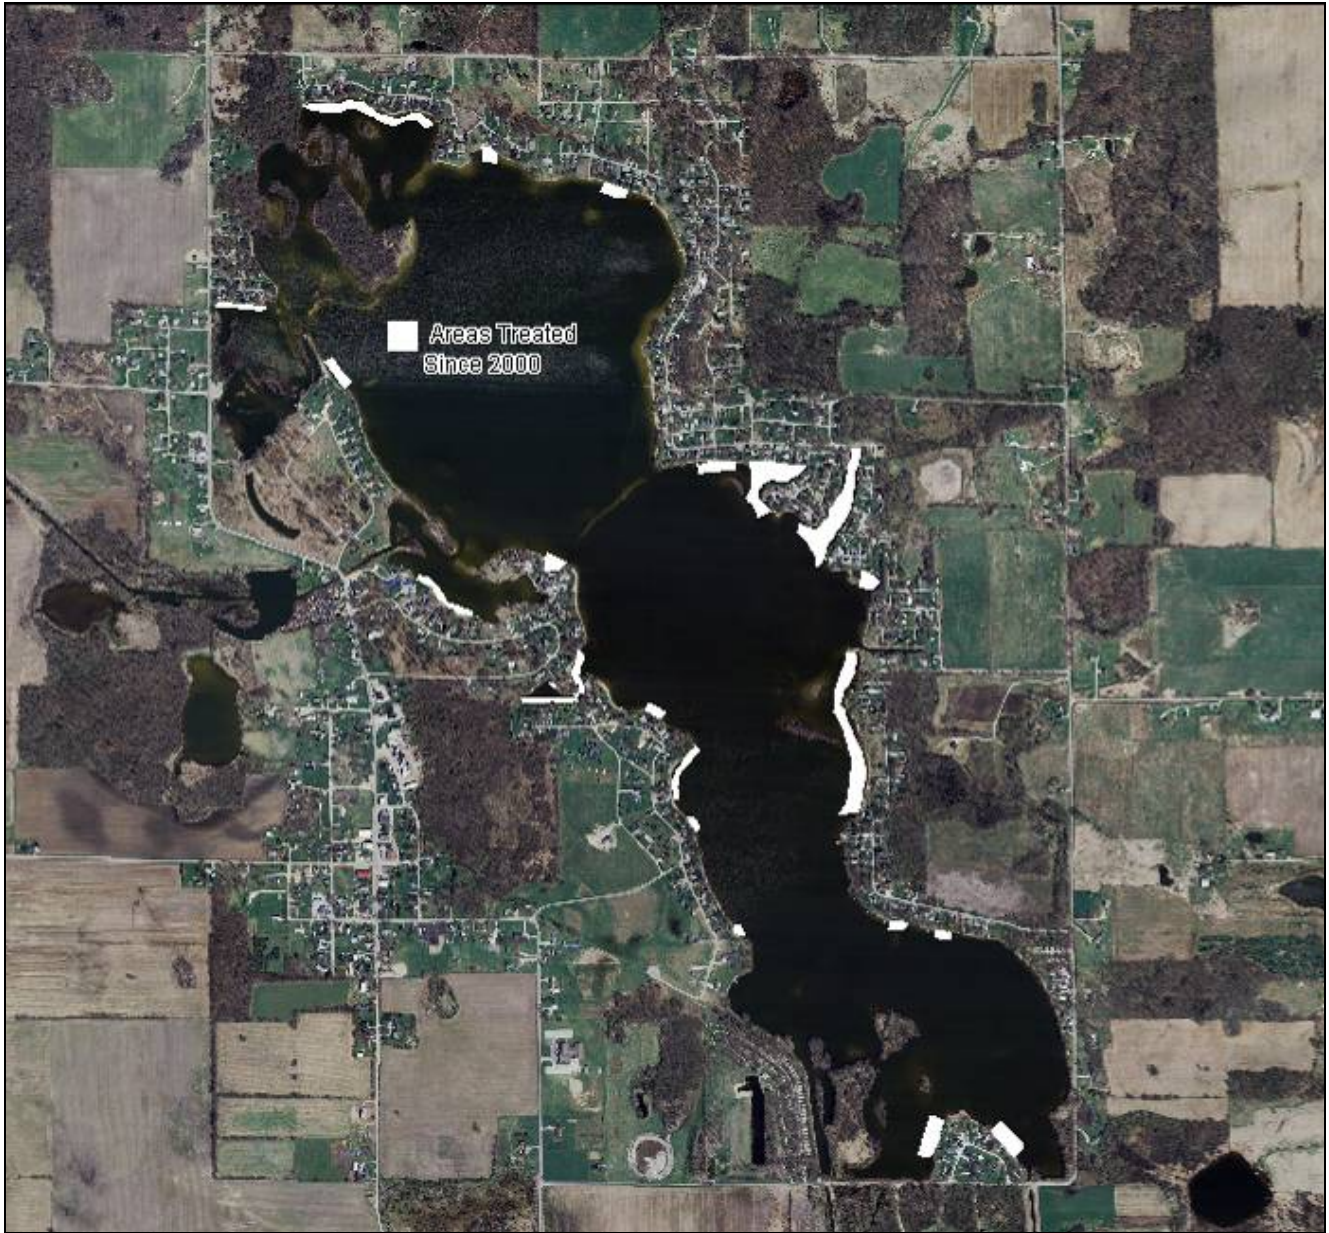
Figure 7 Areas of Big Turkey Lake Where Privately Sponsored Aquatic Plant Treatments Have Taken Place since the Year 2000

While The Big Turkey Lake Association has not maintained an association sponsored plant management program, treatments have taken place in various parts of the lake to control Eurasian watermilfoil, Curlyleaf pondweed and a variety of native plants. These treatments have been sponsored at the subdivision level or by individual property owners or groups of property owners. The total treatment area in a given year has been less than 25 acres. Multiple treatments per season have been needed on many areas due to regrowth and the emergence of new plants in the post-treatment period. Areas that have received treatments for both native and exotic vegetation on Big Turkey in the last seven years are depicted on the lake map below.

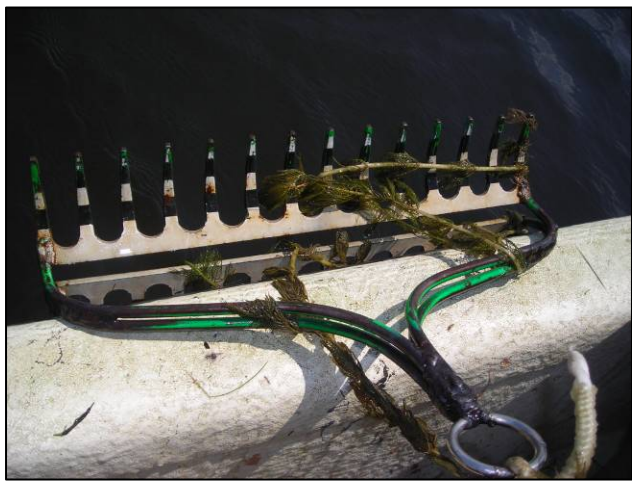
Figure 8 Tier II Plant Sampling Rake

Tier II stratified random sampling was utilized on June 9 and August 10 and 11 of 2007 to establish random plant sampling points and quantify approximate species biomass at each respective point. The Tier II aquatic plant sampling protocol used was established by INDR and is available in full in *Tier II Aquatic Vegetation Survey Protocol, May 2007* (IDNR 2007). In Tier Two sampling, data collection points are established within given depth strata of the lake according to lake size (450 ac. For Big Turkey) and trophic status (Eutrophic) listing. A toss and retrieval of a specially fabricated two sided rake (figure 8) on a rope is used to sample vegetation from the lake bottom at each point. After retrieval of the rake a score is assigned to each recovered plant species by separating the species and placing them back on the rake. The thickness of the plants when placed back on the rake is recorded as measured by equally spaced marks on the rake tines. This measurement assigns a rake score of one, three, or five to each species as a basic measure of biomass. Plants seen but not recovered on the rake are marked as "observed only". Filamentous algae is recorded only as "present" if recovered on the rake. Location data for sampling points was collected using a WAAS enabled GPS unit. Data points were then downloaded to geographic information system (GIS) software for placement on a map. Because aquatic plant species vary in their prominence during various part of the growing season sampling is performed in both the late and early season during plant plan development. In treatment seasons the two survey regime can also allow for a pre-treatment and post-treatment comparison of the

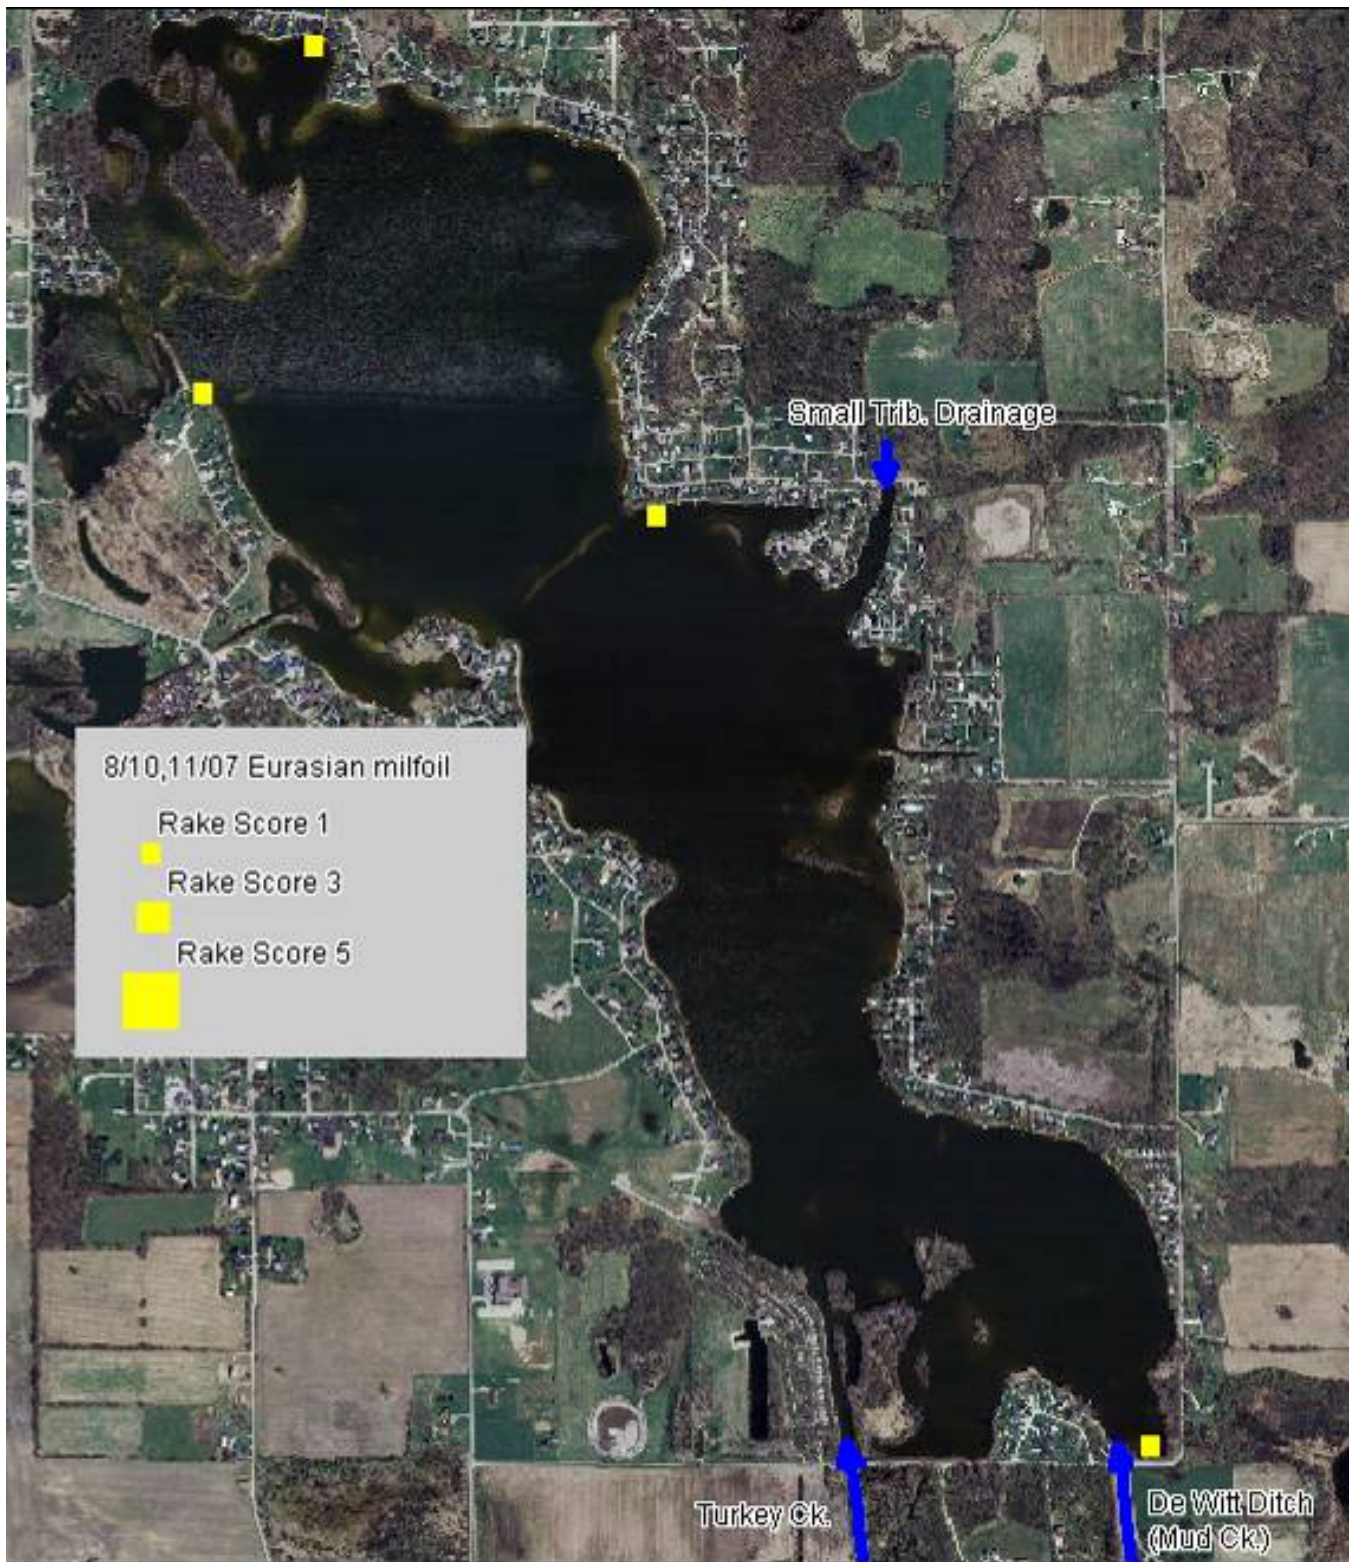
Figure 20 Eurasian watermilfoil Map for the Late Season Tier II Survey

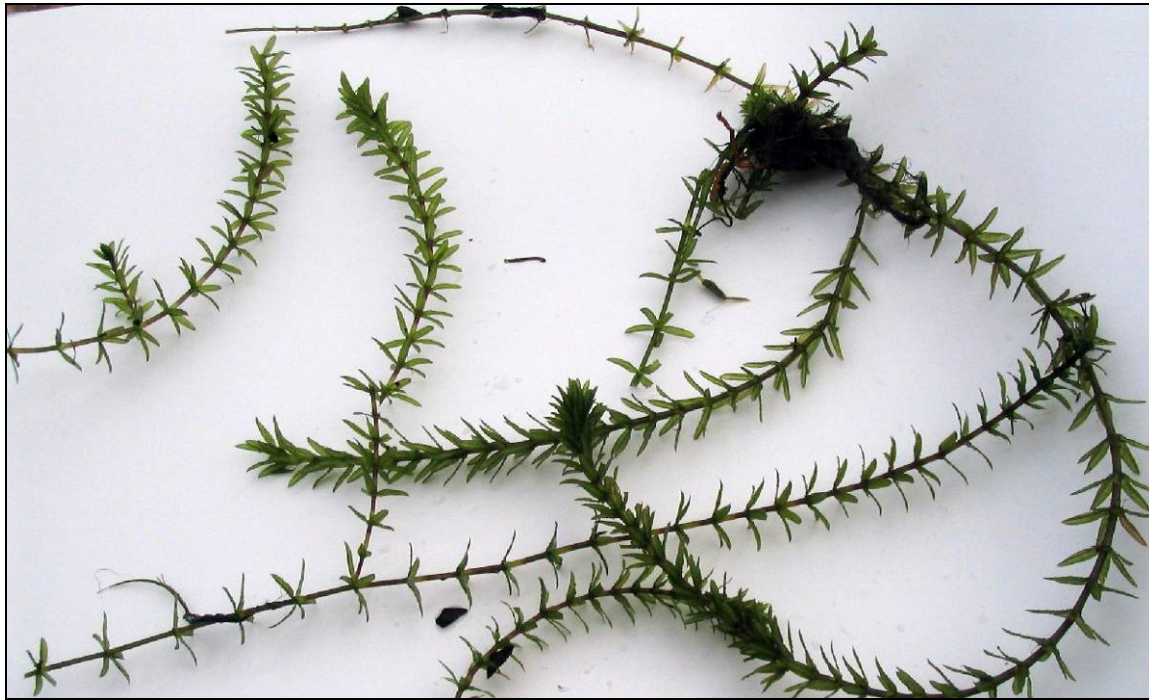
Hydrilla is similar in appearance to the native plant Elodea and also Brazilian elodea, an exotic (also recently found in Indiana). It forms long stems containing many whorls of short leaves. Photo Courtesy of Dr. John H. Rodgers, Jr.

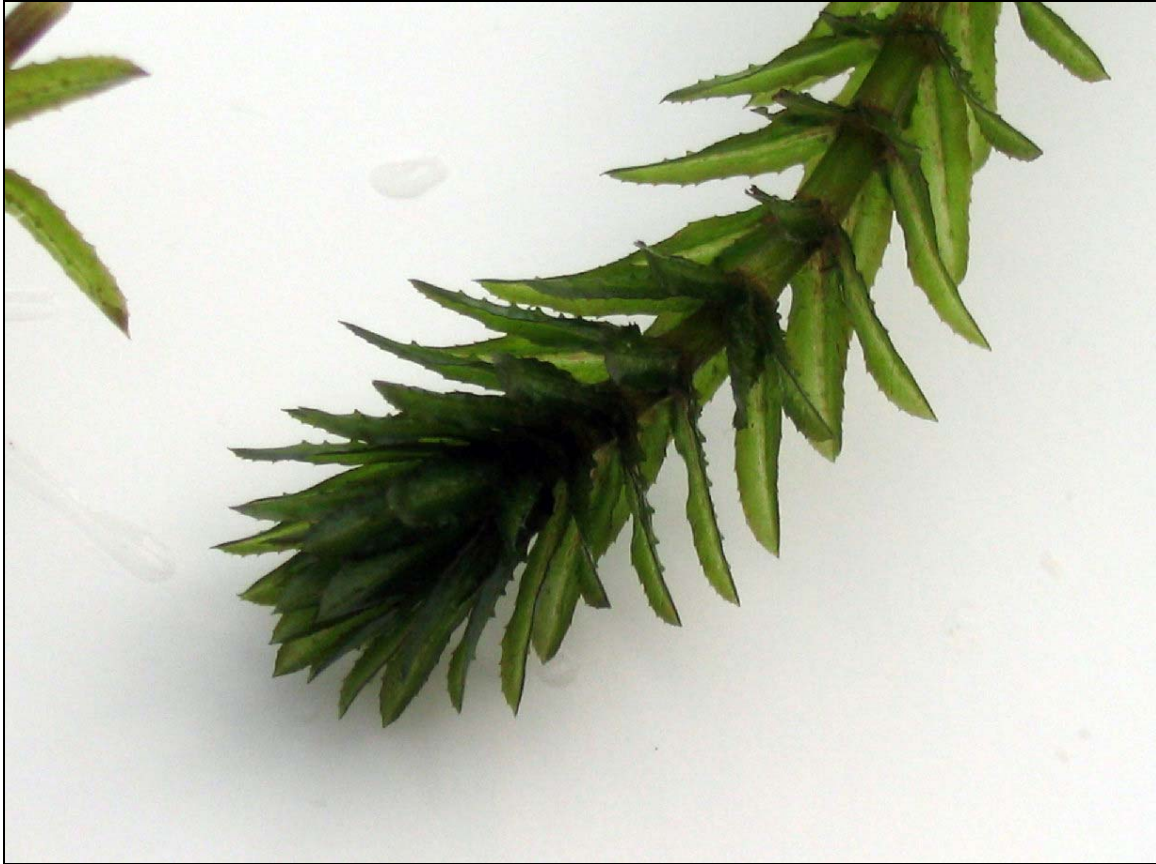
Fig. 2 Edges of Hydrilla leaves have fine serrations visible upon close examination. Photo Courtesy of Dr. John H. Rodgers, Jr.

three, and native Elodea usually has three. (fig 31) Small teeth are also present on the midrib of Hydrilla leaves and may give the plant a “rough” feel. Hydrilla also has small serrations along the leaf edges (fig 32). Another distinguishing characteristic of Hydrilla is the presence of tubers (.2 to .4 inch long off-white structures attached to the root) (fig 33).

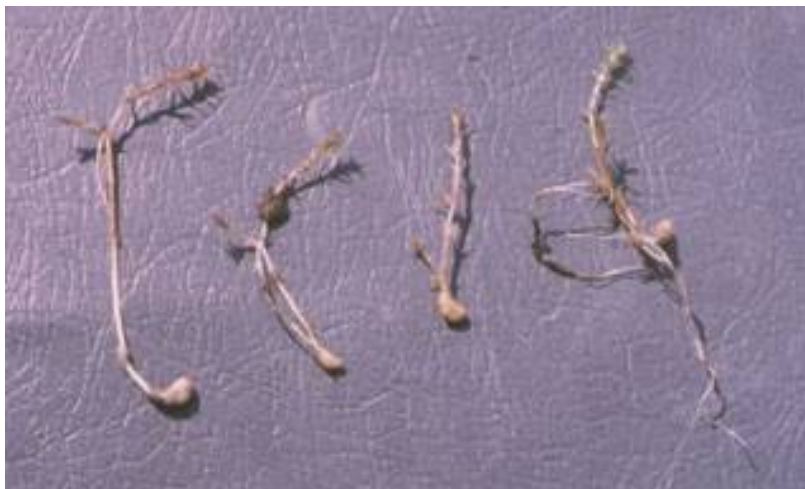
Fig. 3 Hydrilla plants with tubers attached. Photo courtesy of King County Natural Resources and Parks, Water and Land Resources Division.
